Report on the Investigation of the Natural Gas Invasion of Aquifers in Bainbridge Township of Geauga County, Ohio

September 1, 2008
Ohio Department of Natural Resources
Division of Mineral Resources Management

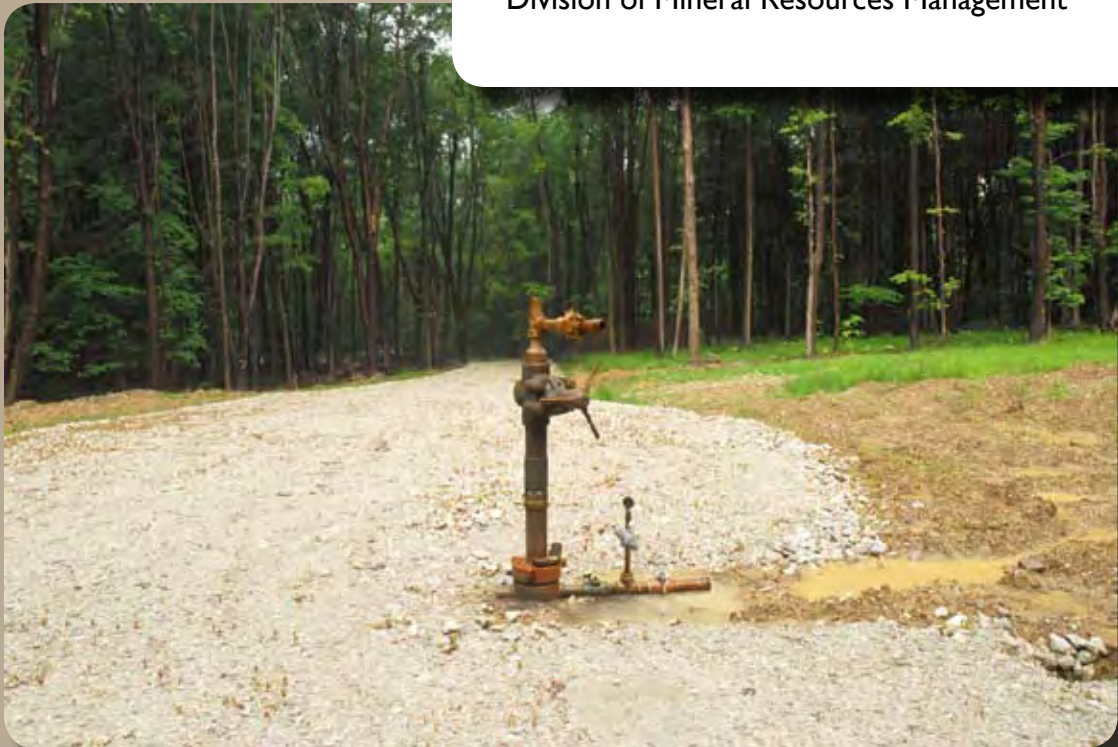
The DMRM determined that accumulation and confinement of deep, high-pressure gas in the surface-production casing annulus of the English No.1 Well, between November 13 and December 15, 2007 resulted in over-pressurization of the annulus. This over-pressurized condition resulted in the invasion, or migration, of natural gas from the annulus of the well into natural fractures in the bedrock below the base of the cemented surface casing. This gas migrated

Three different factors in the drilling and completion of the English No.1 Well are believed to be the primary contributing factors that led to the gas invasion of the shallow aquifers and subsequent explosion in the house on English Drive. The first contributing factor was inadequate cementing of the production casing prior to remedial cementing on December 15 2007. The second contributing factor was the decision to proceed with stimulating, or hydro-fracturing, the well without addressing the issue of the minimal cement behind the production casing. Hydro-fracturing is the process in which fluid is pumped into the oil and gas reservoir through perforations in the production casing to enhance fractures and improve the flow of gas and/or crude oil into the production casing. Finally, the third and most critical contributing factor leading to the incident was the 31 day period after the fracturing stimulation of the “Clinton” sandstone during which the annular space between the surface and production casings was mostly shut in. This confined the deep, high-pressure gas from “Newburg” and/or “Clinton” within this restricted space. Readings taken and reported by OVESC during this shut in period were consistently 320 psi or greater.

The DMRM has determined that accumulation and confinement of deep, high-pressure gas in the surface-production casing annulus of the English No.1 Well, between November 13 and December 15, resulted in over-pressurization of the annulus. This over-pressurized condition resulted in invasion of natural gas from the annulus of the well into natural fractures in the bedrock below the base of the cemented surface casing. This gas migrated vertically through fractures into the overlying aquifers and discharged through local water wells. Three successive events in the drilling and completion of the English No.1 Well are believed to be the primary contributing factors that led to the gas invasion of the shallow aquifers and subsequent explosion in the house on English Drive.

The first contributing factor was inadequate cementing of the production casing prior to remedial cementing on December 15. The industry standard for cementing production casing calls for sufficient cement to fill the annulus between the well bore and the casing 600-800 feet above the "Clinton". At this height, the "Newburg" zone, which can be gas and/or brine bearing, is effectively sealed from the well bore and presents no further problem in completing the well. 175 sacks of Unitropic cement was ordered and run for the primary cement job for the English No.1. Theoretically, this amount should have provided more than enough fill up to cover and seal the "Newburg" at 3350 feet. However, the bond log run on November 1 indicates the top of cement was only at 3640 feet, the level of the "Packer Shell" and approximately 300 feet below the "Newburg". It appears from the record that the "Packer Shell" in the English No.1 Well is naturally fractured to the extent that it "thieved" most of the cement that was pumped into the well. The result was that the borehole was exposed to high pressure gas from the "Newburg" and any other deep source of gas.

The second contributing factor was the decision to proceed with stimulating the well without addressing the issue of the minimal cement behind the production casing. Hydraulic fracture stimulation normally involves injecting fluids and sand into the oil and gas reservoir to enhance the flow of hydrocarbons to the well bore. When a well is properly constructed, the hydraulic fracture is confined between the permitted reservoir formation and the production casing. The abnormal circulation that was observed during the stimulation of the English No.1

Finally, the third and most critical contributing factor leading to the incident was the 31 day period after the fracturing stimulation of the Clinton formation during which the annular space between the surface and production casings was mostly shut in. This confined the deep, high-pressure gas from “Newburg” and/or “Clinton” within this restricted space. Readings taken and reported by OVESC during this shut in period were consistently 320 psi or greater. Typically, shallow shale gas does not register more than 30-60 psi on the annulus and can be closed in or vented without problem. Pressures of the order that were observed would indicate a deeper source of the gas present in the annulus. This was not recognized by OVESC personnel who opened the valve to blow off the pressure but continued to close the annulus valve when not on site. As pressure on the annulus built up, the gas migrated laterally and vertically through natural fractures in the surrounding bedrock. This over-pressurized gas infiltrated the local aquifers, discharged through local water wells, allowing gas to enter some area homes in varying concentrations, and resulting in the explosion at one home.

1. Inadequate primary cementing of the production casing has been remedied by the subsequent squeeze cementing operations;
2. The deep high-pressure gas zones that were the source of over-pressurization of the aquifers have been isolated and sealed from the well bore through the squeeze cementing procedures;
3. The confinement of annular gas, which caused the build up of pressure, has been eliminated.
