General Technical
Report NRS-76

EFFECTS OF DEVELOPMENT OF A NATURAL GAS WELL AND ASSOCIATED PIPELINE ON THE NATURAL AND SCIENTIFIC RESOURCES OF THE FERNOW EXPERIMENTAL FOREST

Mary Beth Adams, Pamela J. Edwards, W. Mark Ford,
Joshua B. Johnson, Thomas M. Schuler,
Melissa Thomas-Van Gundy, and Frederica Wood

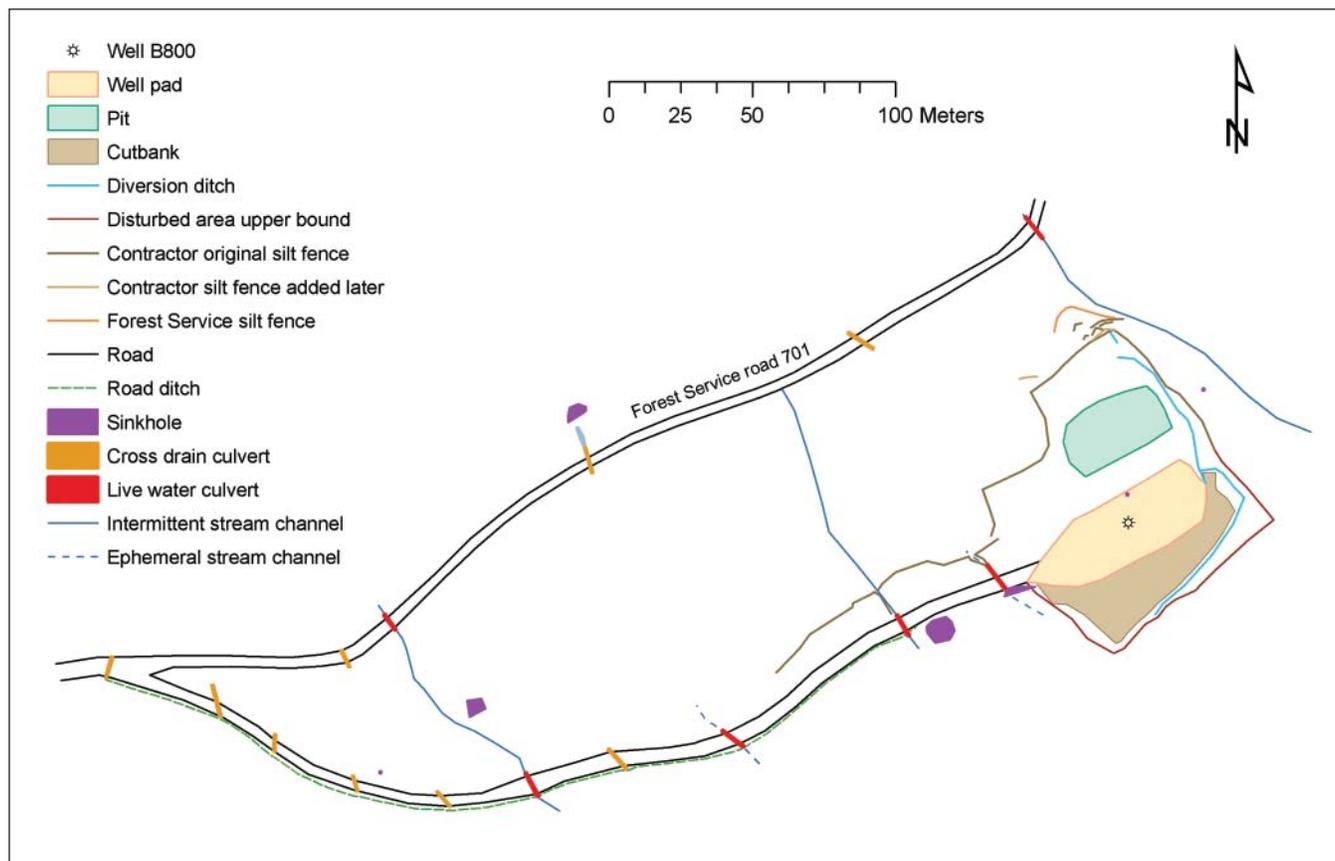
Figure 2.—Diagram of B800 well site, Fernow Experimental Forest, showing locations of water and sediment control devices and of water and sediment areas of concern (from Edwards 2008).

Initially, the energy company installed silt fences to reduce sediment loss and delivery from the well site, primarily around the perimeter of the well pad site and along the access road (Fig. 2). However, within a relatively short time, the perimeter silt fence was undermined or overtopped along much of its length. The silt fence was least effective in the northern corner of the site because water was rerouted and allowed to concentrate. A relatively large amount of subsurface flow became emergent and remained as concentrated overland flow as the result of the construction of the cutbank around the well pad. This water provided the energy to destabilize, dislodge, and transport exposed soil from the cutbank. Heavy rains on March 4 and 5, 2008, spurred further erosion. During this rainstorm, the concentrated flow and associated sediment initially was routed to a sinkhole (Fig. 2). An unknown

amount of eroded soil entered the sinkhole during that storm period. On March 7, 2008, energy company contractors constructed a trench in the upper portion of the cutbank and just inside the perimeter of the silt fence along the eastern side of the well pad and pit area to reroute water and sediment away from the sinkhole.

However, the rerouting of additional water and sediment inside the perimeter fence resulted in the silt fence being overtopped and further undermined in the northern corner. Consequently, five additional short lengths of silt fence (totaling 28.2 m) were installed further downslope to help reduce the water flow and retain sediment. These additional sections of silt fence still did not fully contain sediment coming from the site. The visible evidence suggested that the water infiltrated the soil and the eroded soil settled out before reaching the ditchline on FS701. Also, because of the evidence of extended soil transport and elevated erosion, an additional 27.2-m length of silt fence was installed downslope of the contractor's silt fence by the Forest Service on May 5, 2008 (Fig. 2).

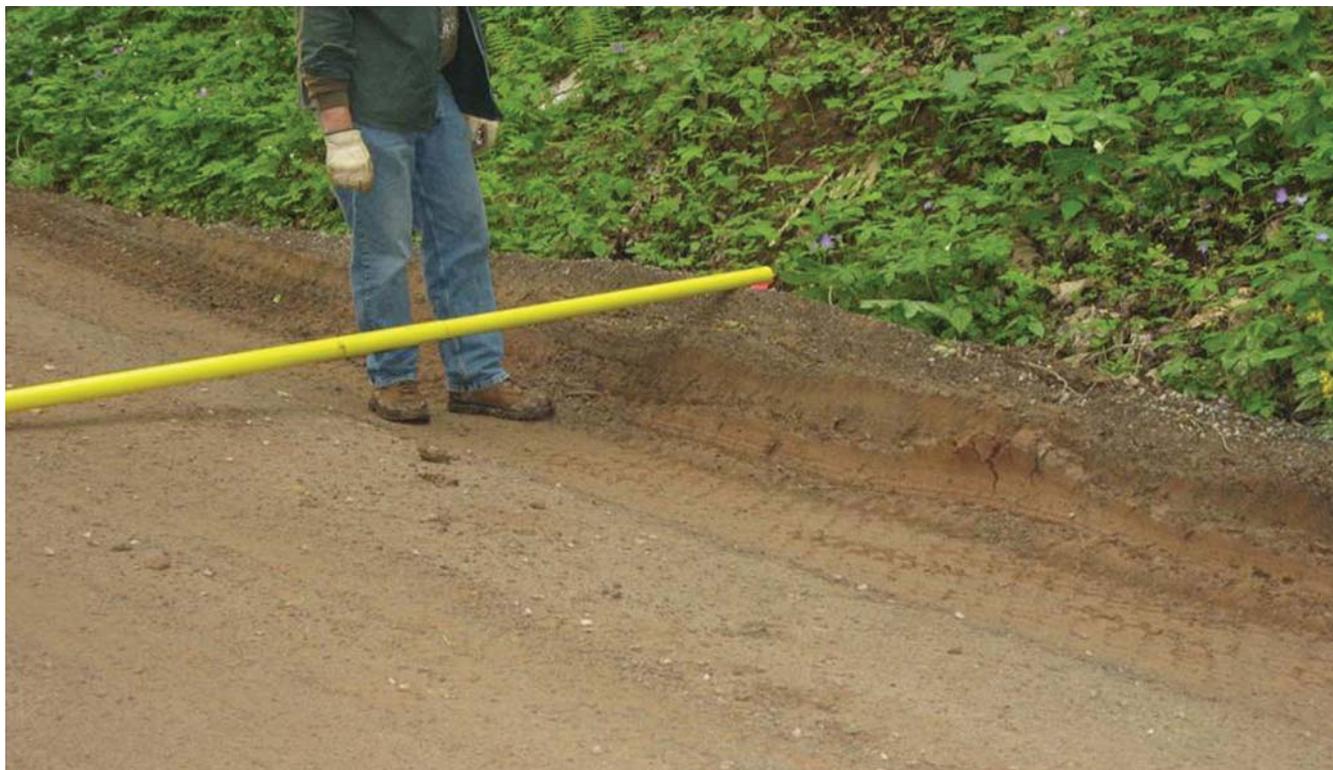
Some damage to roads was expected and was observed during site development and drilling (Fig. 3), despite spot graveling. Ruts of 30 cm or greater developed, roadside drainage ditches were filled or collapsed, and erosion of the road surface subsequently occurred. The problem appeared to be caused by heavy vehicle traffic when the roads were very wet, and insufficient preventive graveling. Conditions were such that FS701 between Big Springs Gap and the McGowan Mountain road (FS324) intersection (about 2 km) was closed to the public for safety reasons. Although some damage was expected, the severity of the impacts was greater than we had expected. After drilling was complete, the roads were repaired by grading and application of stone.

Figure 3.—Damage to road surface and roadside ditch on the Fernow Experimental Forest from gas well construction and drilling equipment. Note that the drainage ditch has been obliterated. Photo taken May 22, 2008. Photo by U.S. Forest Service.

As mentioned earlier, substantial damage to roads occurred during site development and drilling. Because loaded log trucks regularly use Fernow roads, we anticipated a similar level of damage. However, the estimated total weight of trucks required for developing the well site was substantially greater than that of logging trucks during a normal year (an estimated 10,218 tons [MNF Road Use Permit] compared to 5,000 tons for logging), which may explain the greater than expected damage. For instance, obliteration of ditches rarely, if ever, occurs on the Fernow main roads due to traffic from logging trucks. We also expected that damage would be repaired as soon as it occurred or was pointed out; instead, the damage was repaired after completion of well site construction and drilling. Some runoff and erosion from roads and loss of road function were observed as a result of this delay in maintenance, but were not quantified.

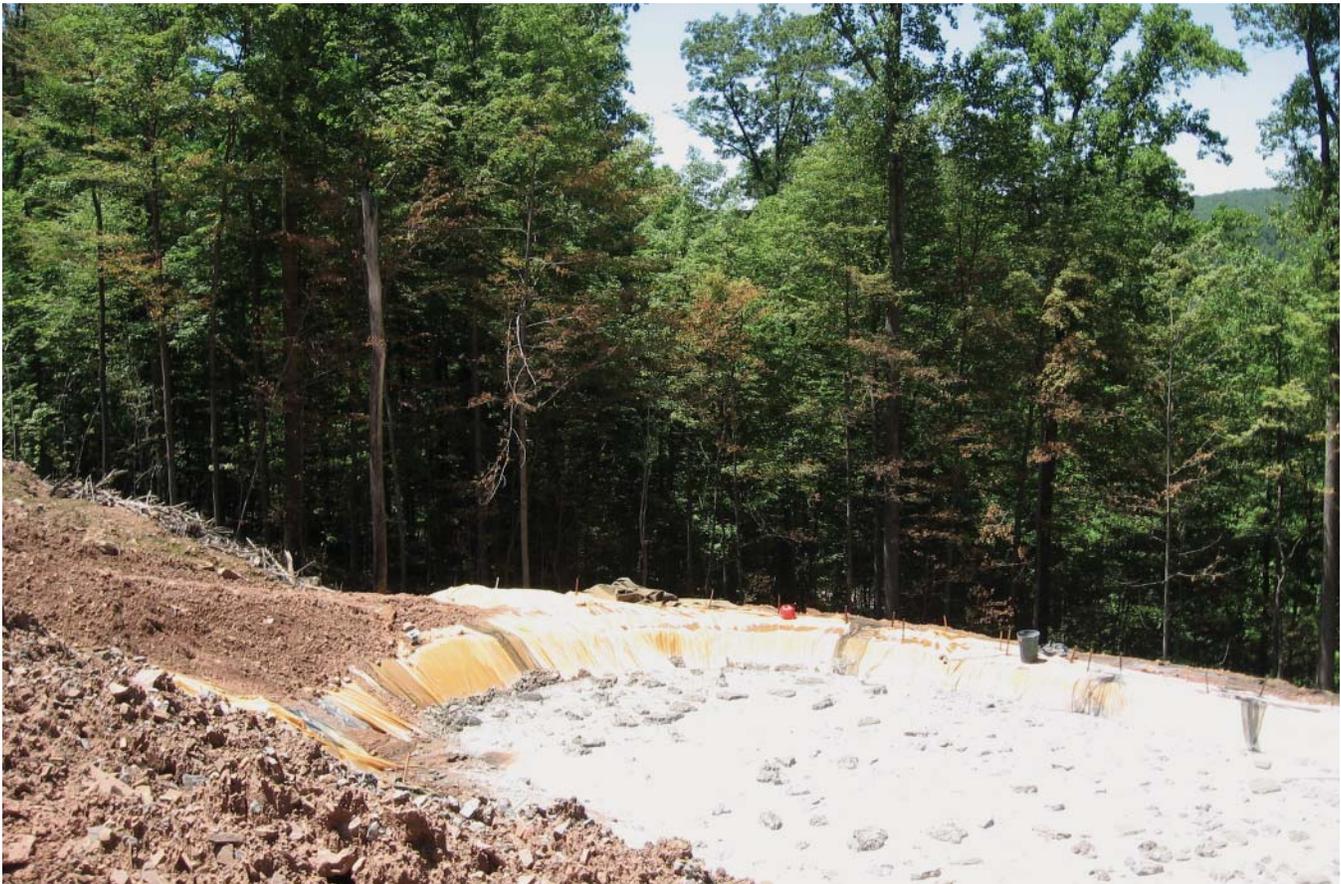
On June 11, 2008, damage to about two dozen trees was noted immediately adjacent to the well pad on the lower west side by Fernow staff. Browning of foliage and a lack of ground vegetation for several meters into the residual stand were observed (Fig. 4). Many of the trees subsequently dropped their foliage. These symptoms were attributed to a loss of control of the drill bore on May 29, 2008, resulting in an aerial release of materials that drifted over areas immediately

Figure 4.—Foliar injury of trees damaged by aerial release of drilling fluids on May 29, 2008, from the B800 well. Pit containing drilling fluids is shown in the foreground. Photo taken June 11, 2008. Photo by U.S. Forest Service.

adjacent to the well pad and drill pit. These effects were still evident several months later in the autumn, prior to leaf fall. Trees showed no noticeable symptoms in the summer of 2009. Fluids in this release may have had high pH levels from the tallow plug used to hold the fracturing fluids in the formation. Because a major component of the fracturing fluids was hydrochloric acid (15 percent; Well Operator's Report, AP1#47-093-00107, available from the WV DEP), an alternative explanation may be that a low pH solution containing high chloride levels is responsible for the observed symptoms. Clearly, a better knowledge of the chemical makeup of the drilling and hydrofracing fluids is needed in order to understand and predict possible impacts on the resources.

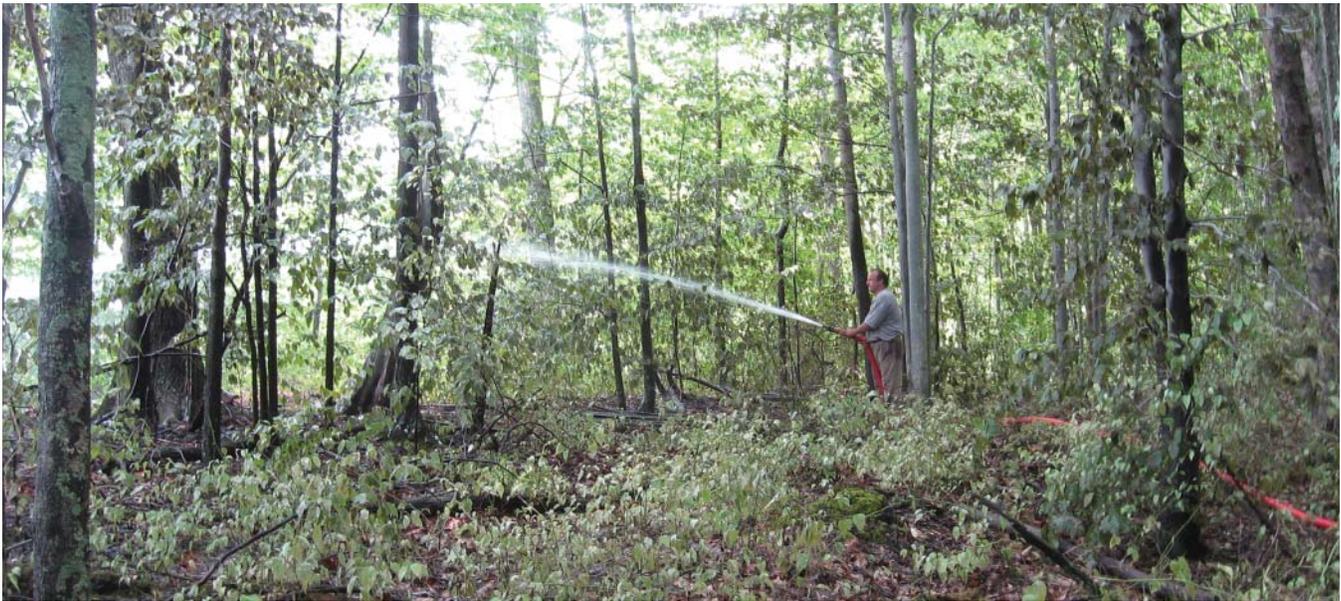
spraying the fluid into the air and, in this instance, onto the vegetation (Fig. 5). It was assumed that if the drill pit fluids met the standards specified in the permit, there would be no damage to the vegetation or soil. Levels permitted by WV DEP for this pit were chlorides below $12,500 \text{ mg L}^{-1}$ and a pH between 6 and 10. Note that these are concentrations and not loads. An estimated 302,800 L of drill pit fluids were applied to an area of about 0.20 ha in subcompartment 17B (fluid application site 1). Fluid application site 1 represents 2.6 percent of subcompartment 17B. The fluid application area was deliberately kept small in area in order to minimize possible impacts to the ongoing research. This intent obviously backfired. The second fluid application site was located within the pipeline ROW corridor (fluid application site 2) along the boundary of compartments 17 and 19 and received an estimated 75,700 L of drilling pit fluids.

Figure 5.—Land application of drill pit fluids to fluid application site 1, Fernow Experimental Forest, June 2008. Photo by U.S. Forest Service.

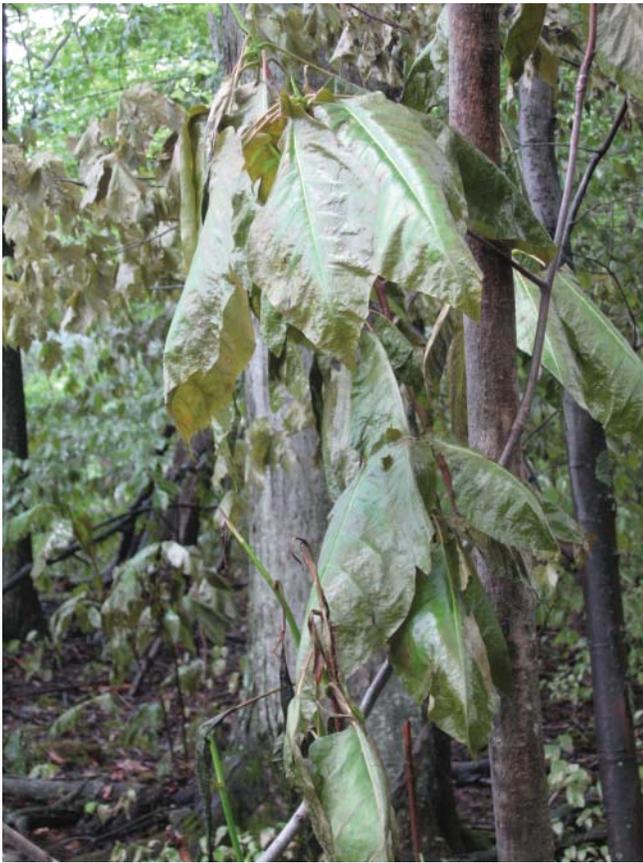
On June 19, 2008, severe browning of foliage on the first fluid application site was discovered by Fernow staff (Figs. 6-8; Table 4). Initial effects were immediately visible on shrubs and small trees; however, within about 10 days, leaves of older trees (> 20 m in height), which were unlikely to have been directly contacted by the spray, were showing similar symptoms, and numerous trees began dropping green (fresh) leaves (Fig. 7). Ground vegetation and vines, including greenbrier, were top-killed or killed outright (Fig. 8). The temporal and spatial development of symptoms suggested that the effects were due to both direct contact of foliage with the spray, and to uptake of the solution from the soil by tree roots. A total of 115 trees (10 species), nearly all of those within the perimeter of the application area, exhibited some symptoms of damage (leaf browning, leaf drop, or twig dieback) in 2008.

Figure 6.—Foliage injury of Fraser magnolia on fluid application site 1, Fernow Experimental Forest. Note damaged red maple foliage in background (upper left). Photo taken June 19, 2008. Photo by U.S. Forest Service.

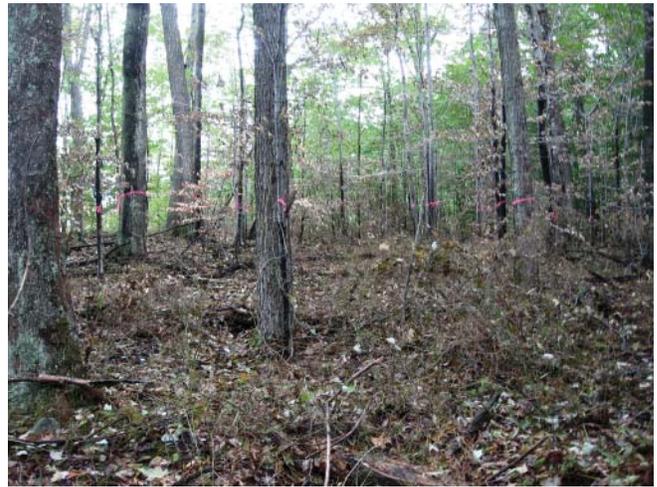
Figure 7.—Fluid application site 1, Fernow Experimental Forest, showing dead and damaged understory vegetation, and freshly fallen green leaves. Red flagging indicates trees showing symptoms. Photo taken July 9, 2008. Photo by U.S. Forest Service.

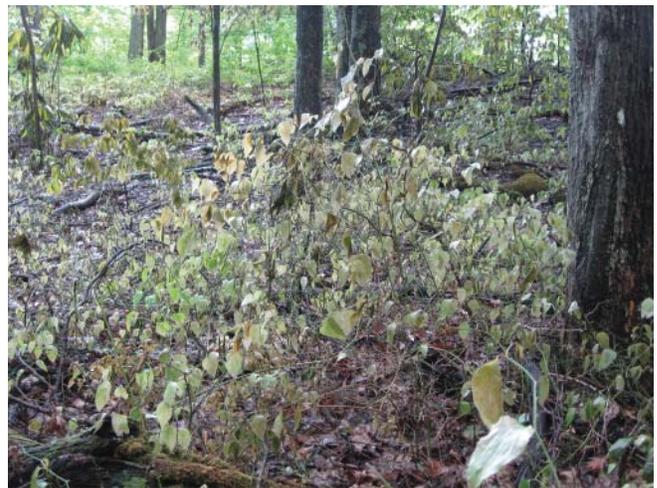
Figure 8.—Damaged greenbrier vines on fluid application site 1, Fernow Experimental Forest. Photo taken June 19, 2008. Photo by U.S. Forest Service.

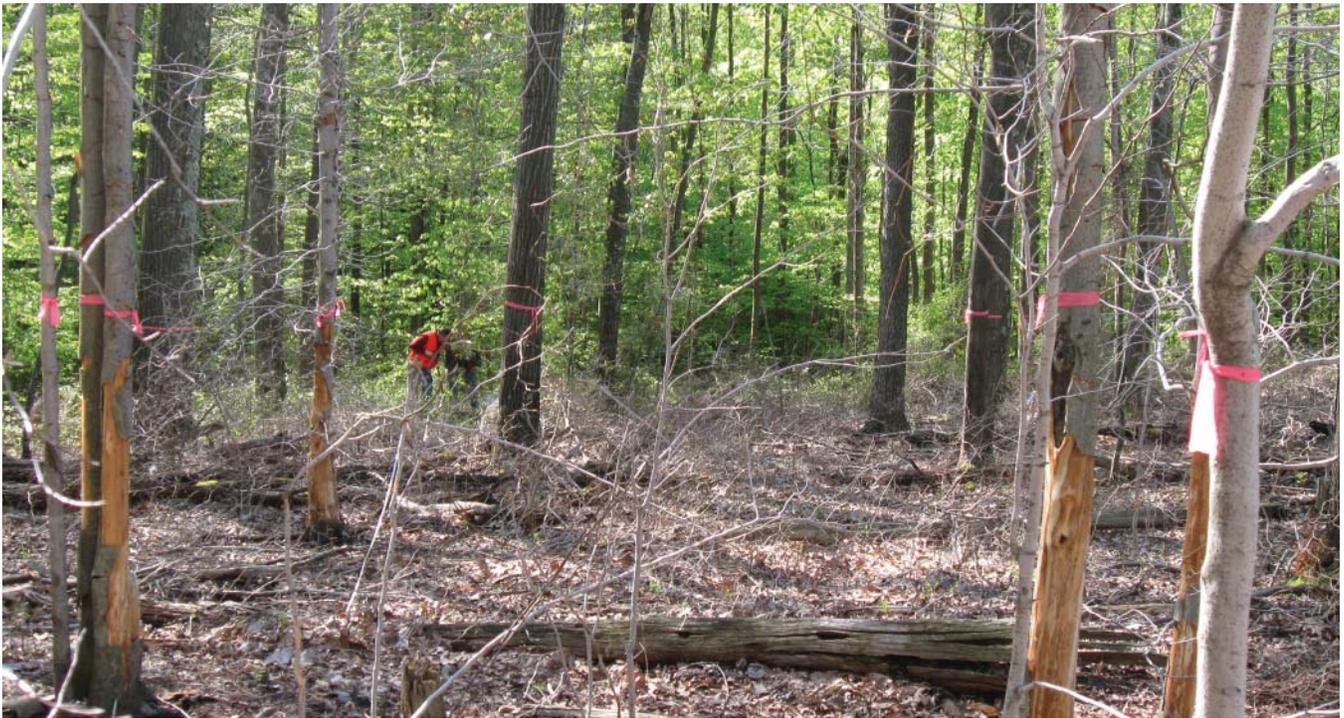
application area were nearly fully leafed out and green (Fig. 9). The 2009 tally included trees that had no symptoms in 2008 and a few trees that had shown symptoms in 2008 but were symptom-free in 2009 (mostly understory red maple trees < 12 cm d.b.h.). Symptoms observed in 2009 included dwarfed foliage, discolored foliage, and bark sloughing. Trees with no live foliage in May 2009 were considered dead. We also looked for evidence of basal-stem or root sprouting, but observed very little sprouting.

Figure 9.—Fluid application site 1, with non-treated forest in background, Fernow Experimental Forest. Photo taken May 17, 2009. Photo by U.S. Forest Service.

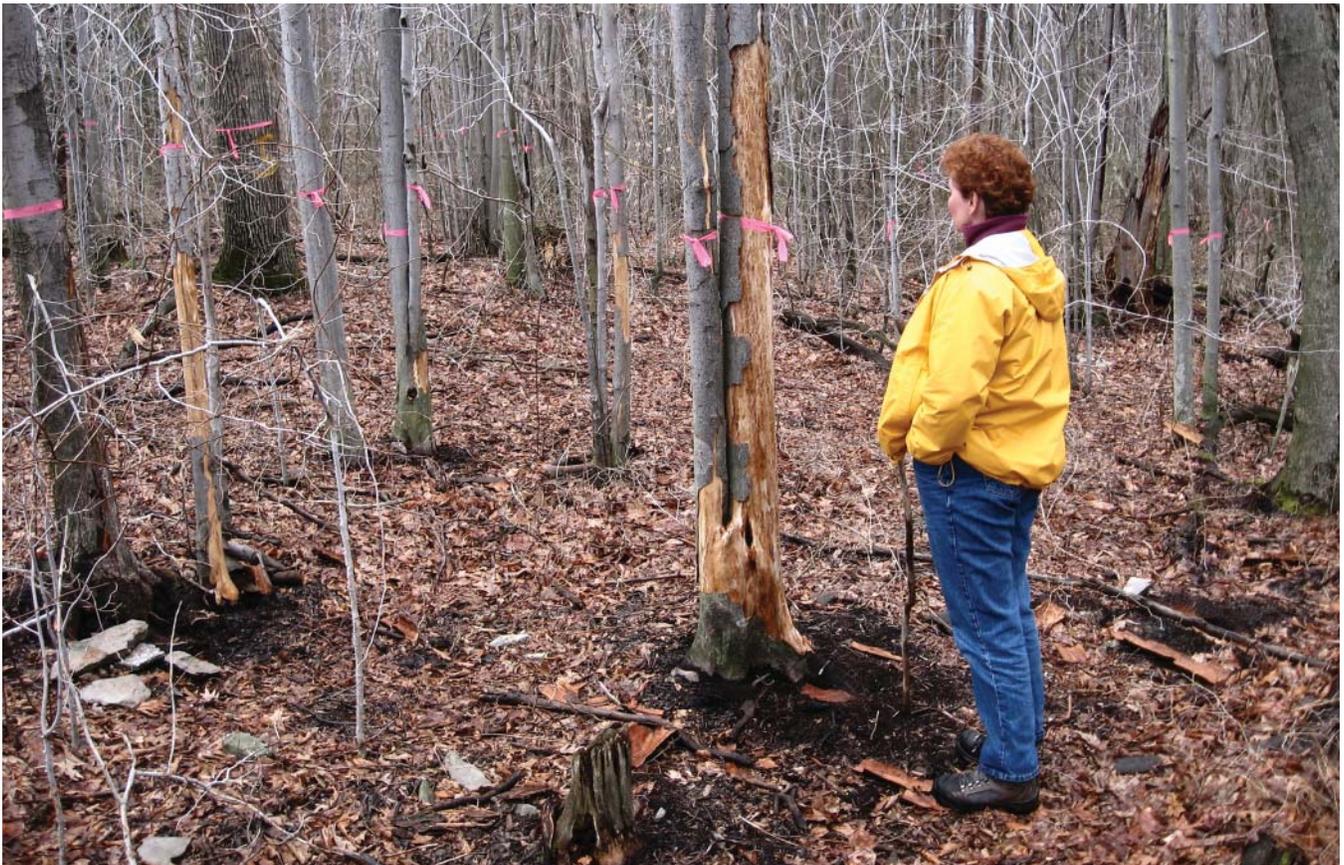
American beech was the most common dead tree species in 2009; about 38 percent of the beech trees experienced bark sloughing (Fig. 10), a dramatic visual response, less than 1 year after fluid application. We also noted that the prolific root sprouting, which is well known and documented for beech, is entirely absent within the fluid application area. Auchmoody and Walters (1988) reported that large beech trees were the last of the hardwoods to die after an accidental brine spill from an oil well development in Pennsylvania, although beech were identified as the deciduous trees most sensitive to salt in a Canadian assessment (Environment Canada 2001). While these observations suggest that beech might be a sensitive indicator of excessive salt levels, other species should perhaps be considered because of the presence of

Figure 10.—Bark sloughing by American beech trees, fluid application site 1, Fernow Experimental Forest. Photo taken April 22, 2009. Photo by U.S. Forest Service.

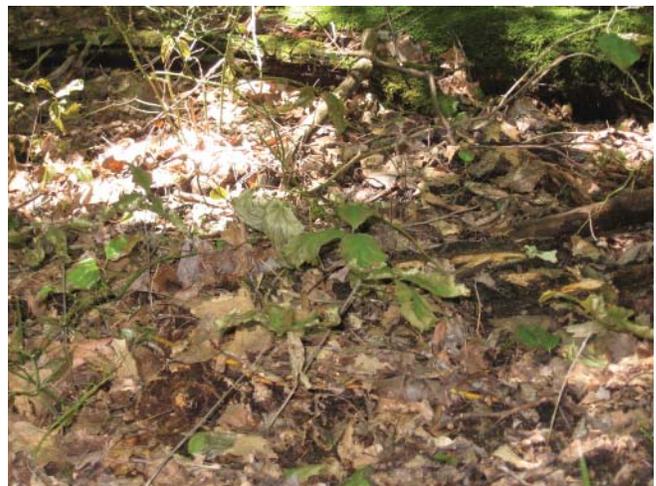
Figure 11.—Damaged oak seedlings and greenbrier vines on fluid application site 2, Fernow Experimental Forest. Photo taken July 25, 2008. Photo by U.S. Forest Service.

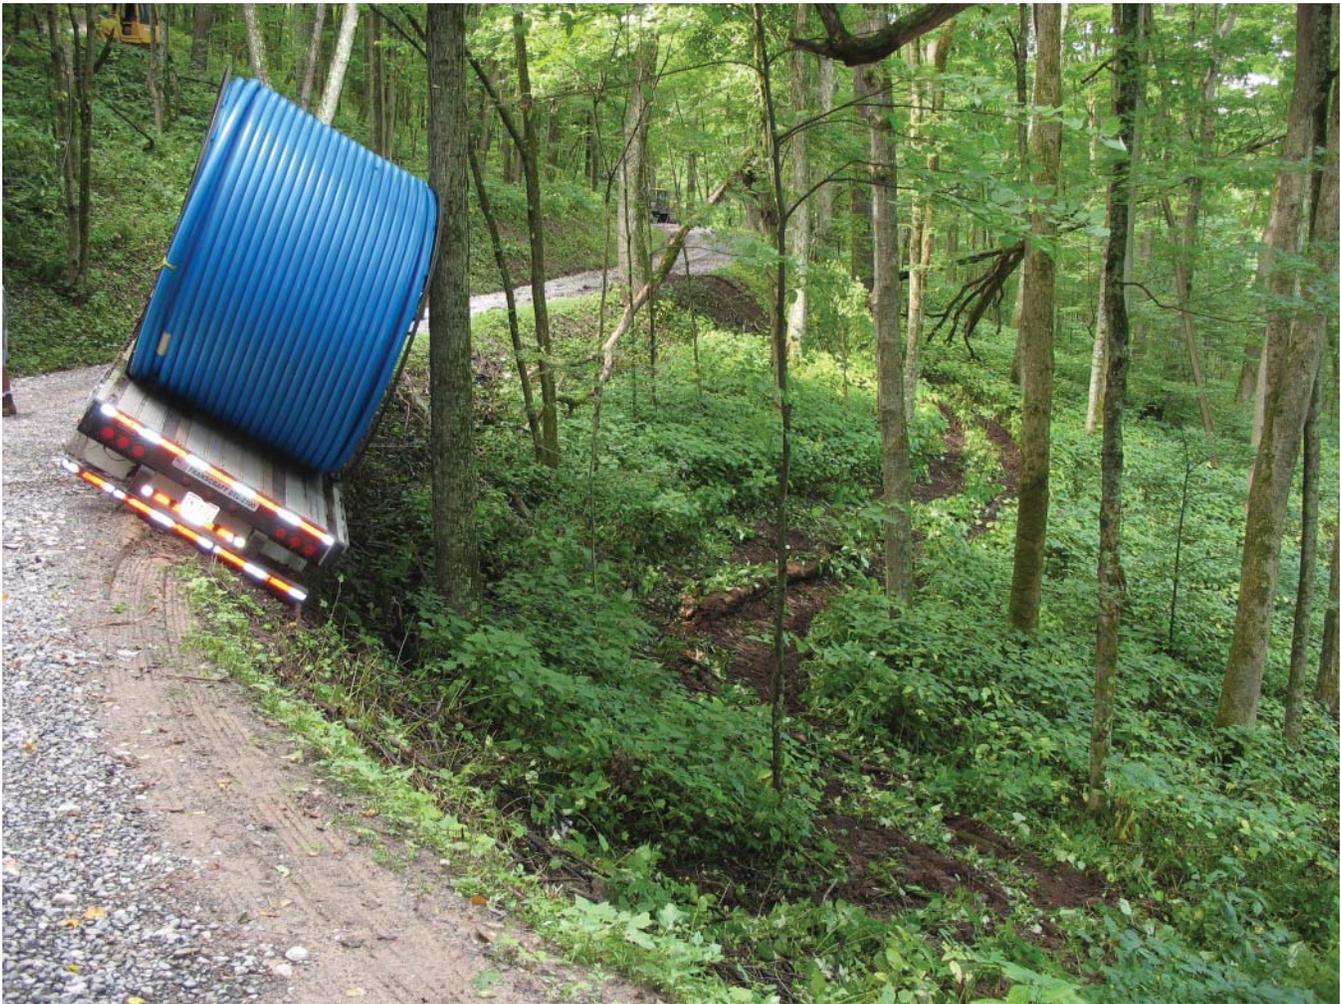
Figure 12.—Biological Control Area, Fernow Experimental Forest, showing damage from truck hauling gas pipeline and from the bulldozer used in an attempt to push the truck back onto the road surface. Photo taken August 13, 2008. Photo by U.S. Forest Service.

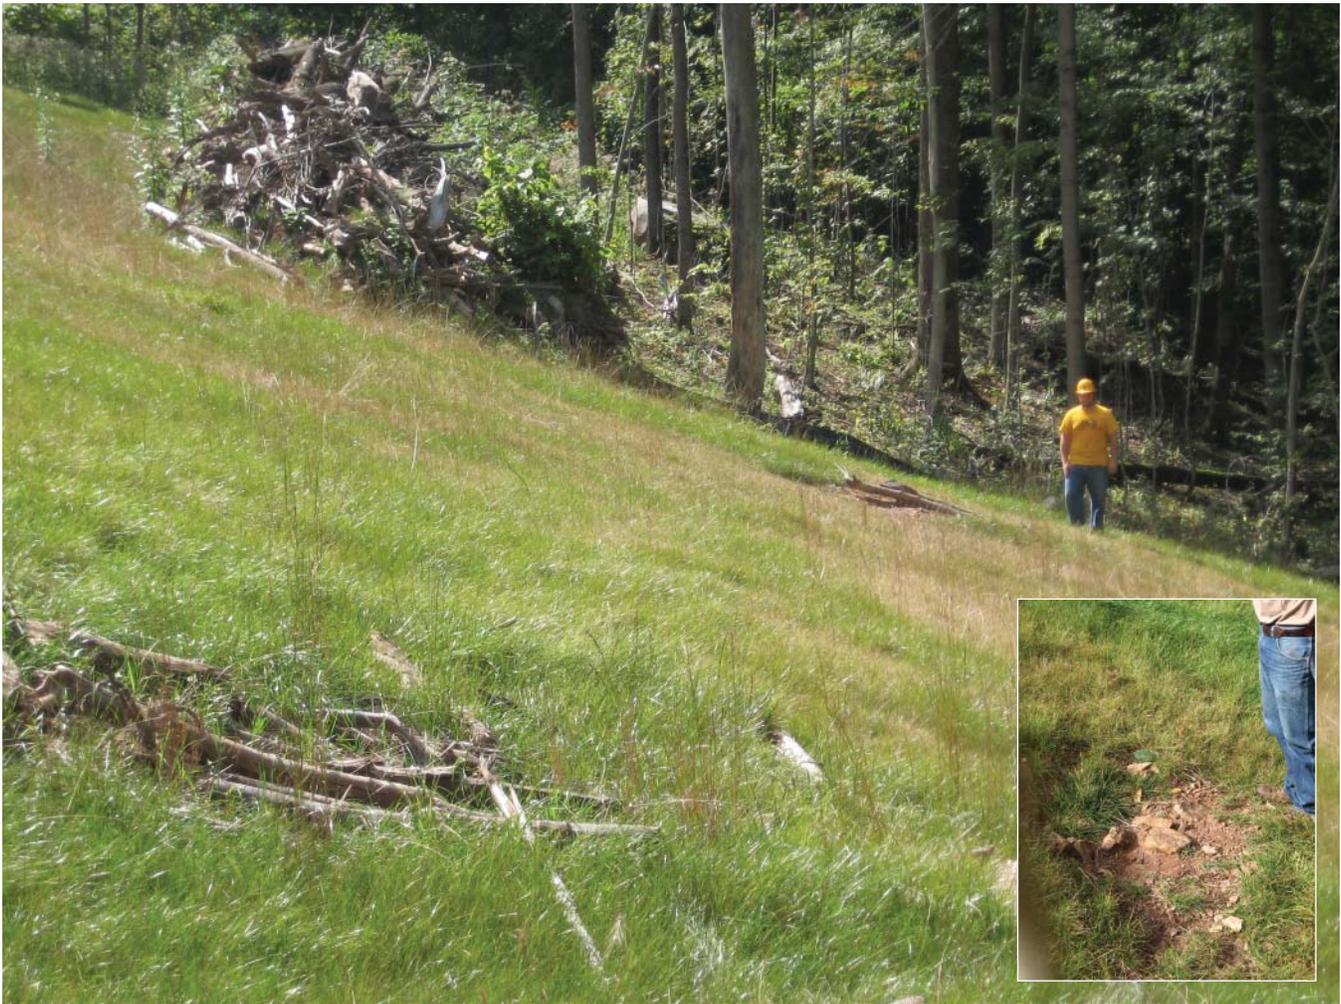
Finally, another unexpected impact was the increased presence and activity of white-tailed deer in areas where the pit fluids were land-applied and on the well site in the area of the buried drill pit. The frequency of hoof prints in the ground at these sites remained unusually high throughout the winter, and into the spring and summer of 2009, indicating that B800 had become a readily used mineral source for deer. Such activity is well documented (Campbell et al. 2004). Increased foraging activities by black bears, as evidenced by turned-over logs, heavily disturbed soil, and bear signs such as foot prints and scat, also were observed within fluid application site 1 and hypothesized to be due to high salt concentrations in soil and vegetation.

Figure 13.—Partially remediated deer lick areas, located near drill pit burial site. Inset photo shows new deer lick area, located to the technician’s right (up slope) in the larger photo. Photos taken September 10 and 18, 2009. Photo by U.S. Forest Service.

Two of the seeps (4.5 m² and 32 m²) in the area of the buried pit were covered with slash to discourage deer use of the area and to enhance germination of ground cover seed. This met with mixed success (Fig. 13), because regeneration became well established on the one seep and reasonably well on the second. However, a third, smaller seep (1.7 m²) was identified in September 2009 and has attracted deer attention. In July 2010, at least two active seep/lick areas still were frequented by deer, and the area disturbed by the deer's activities has increased. Mitigation of increased deer herbivory to establish ground cover may be feasible in these areas, but such mitigation does not deal with the issue of leakage of pit contents through such seeps. High deer numbers could delay or even prevent successful revegetation of an area (Campbell et al. 2006).
